PHOTOGRAPHIC SURVEY OF THE LDEF MISSION

NASA Special Publication 531

Robert L. O'Neal

National Aeronautics and
Space Administration

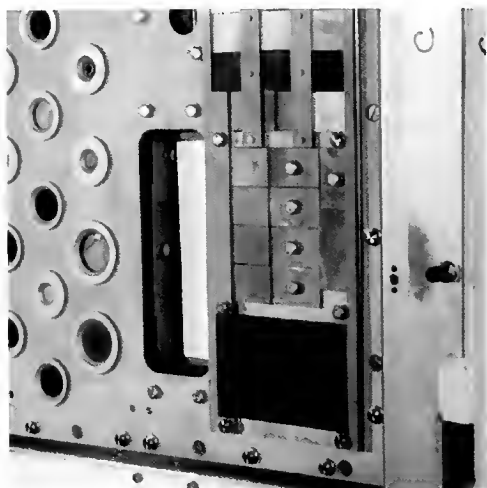
Figure 191
Photo No.: KSC-390C-1931.12
Dup. Neg. No.: L91-8067
LISAR No.: EL-1994-00434
Photo Credit: KSC
Photo Date: 3/14/90
Location: KSC SAEF II
Subject: Postflight Detail of Lower Right of Tray B8

Figure 191 (Postflight). This photograph is of the lower right one-fourth of the module for experiment AO056. The experiment is intact, but brown discolorations appear on surfaces of the Materials Technology Experiment samples that are mounted in the right half of the module.

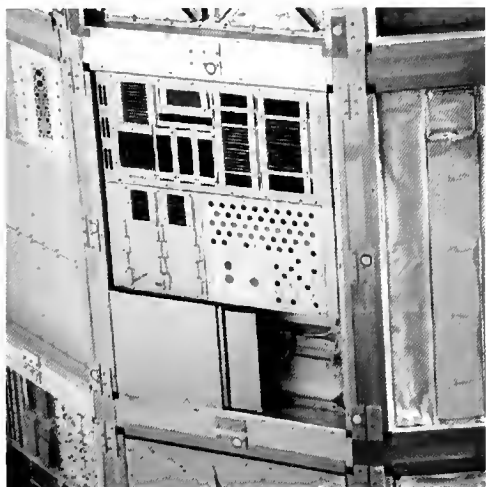
Figure 193
Photo No.: S32-76-001
Dup. Neg. No.: L90-10374
LISAR No.: EL-1994-00659
Photo Credit: JSC
Photo Date: 1/12/90
Location: In Flight
Subject: In-Flight Survey of Tray B9

Figure 193 (In Flight). In this photograph, the top and lower flanges have abrasions from prelaunch testing. Experiment AO147 component, located on the upper one-third of the tray mounting plate, is intact and the mounting hardware appears secure. Much of the mounting hardware is discolored. In the left center, only a few fragments of the 14 polymeric and resin thin-film materials have survived the mission.

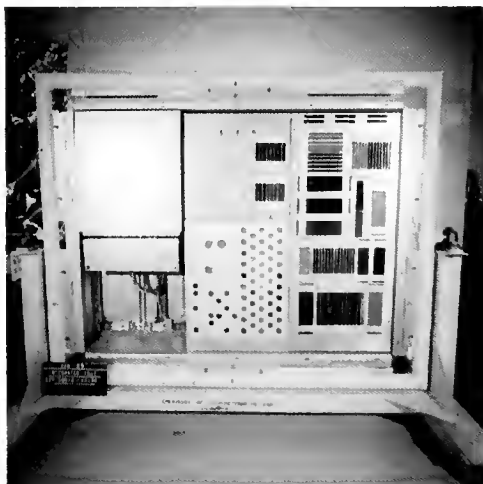
Figure 194
Photo No.: KSC-390C-1913.09
Dup. Neg. No.: L91-2536
LISAR No.: EL-1994-00281
Photo Credit: KSC
Photo Date: 3/13/90
Location: KSC SAEF II
Subject: Postflight Survey of Tray B9

Figure 194 (Postflight). The right and left flanges and each end of the top flange of the tray have abrasions from prelaunch testing. Most test specimens are intact except in the upper left center one-third where many thin films are damaged or missing. Mounting hardware is discolored. The EECC located in the left section of the experiment tray has a dark brown discoloration on the mounting structure in the bottom of the tray.

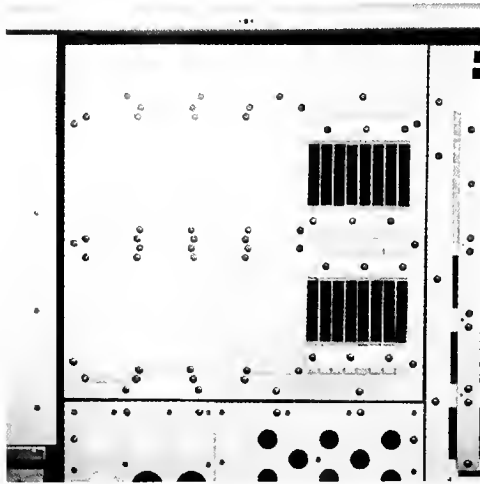
Figure 195
Photo No. KSC-390C-1913.11
Dup. Neg. No.: L91-2538
LISAR No.: EL-1994-00419
Photo Credit: KSC
Photo Date: 3/13/90
Location: KSC SAEF II
Subject: Postflight Detail of Upper Center of
Tray B9

Figure 195 (Postflight). This photograph of the upper center one-sixth of the tray shows that thin-film test specimens are missing. There is a brown discoloration at the upper left corner of the baseplate.

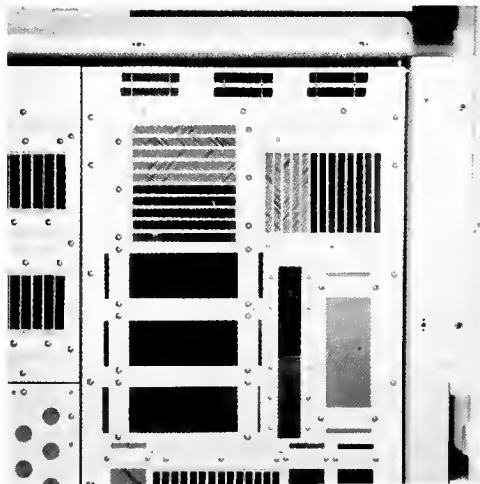
Figure 196
Photo No.: KSC-390C-1913.12
Dup. Neg. No.: L91-2539
LISAR No.: EL-1994-00420
Photo Credit: KSC
Photo Date: 3/13/90
Location: KSC SAEF II
Subject: Postflight Detail of Upper Right of Tray B9

Figure 196 (Postflight). This photograph of the upper right one-sixth of the tray shows that the test specimens are intact. However, some specimens are somewhat discolored and some have diagonal markings and patterns.

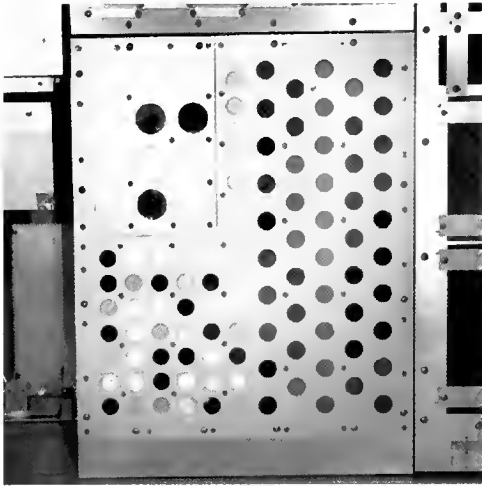
Figure 197
Photo No.: KSC-390C-1914.03
Dup. Neg. No.: L91-8108
LISAR No.: EL-1994-00421
Photo Credit: KSC
Photo Date: 3/13/90
Location: KSC SAEF II
Subject: Postflight Detail of Lower Center of
Tray B9

Figure 197 (Postflight). This photograph of the lower center one-sixth of the tray shows that some test specimens have changed color and some appear damaged.

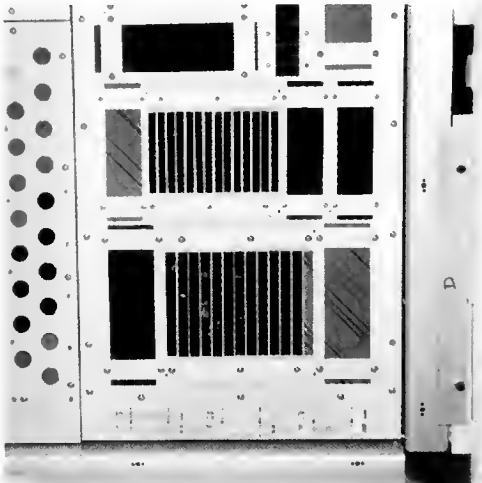
Figure 198
Photo No.: KSC-390C-1914.04
Dup. Neg. No.: L91-8109
LISAR No.: EL-1994-00422
Photo Credit: KSC
Photo Date: 3/13/90
Location: KSC SAEF II
Subject: Postflight Detail of Lower Right of Tray B9

Figure 198 (Postflight). This photograph of the lower right one-sixth of the tray shows that the test specimens are intact, but some are discolored and some have diagonal markings and patterns.

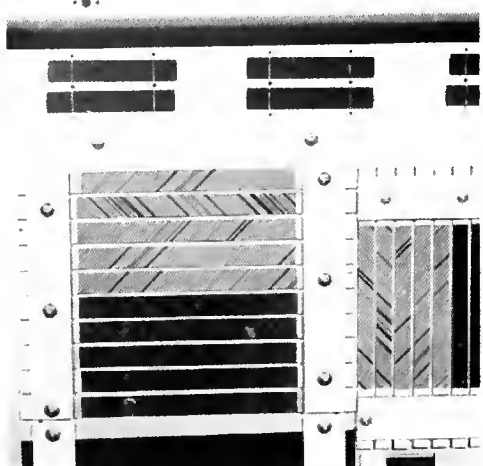
Figure 199 (Postflight). This close-up photograph shows the general discoloration of a group of test specimens in the upper right of the tray.

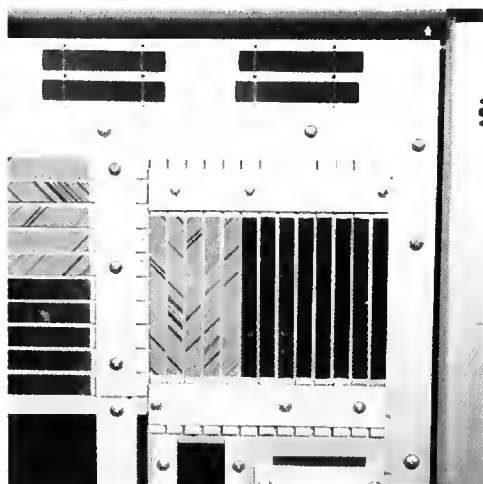
Figure 200 (Postflight). This close-up photograph shows the general discoloration of a group of test specimens in the upper right of the tray.

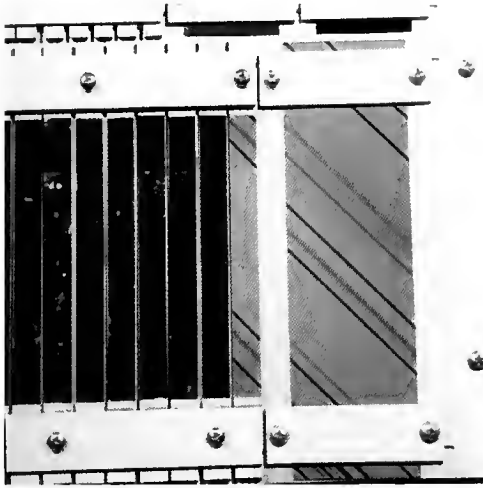
Figure 201
Photo No.: KSC-390C-1916.02
Dup. Neg. No.: L91-8083
LISAR No.: EL-1994-00425
Photo Credit: KSC
Photo Date: 3/13/90
Location: KSC SAEF II
Subject: Postflight Detail of Lower Right of B9

Figure 201 (Postflight). This close-up photograph shows the general discoloration of a group of test specimens in the lower right of the tray.

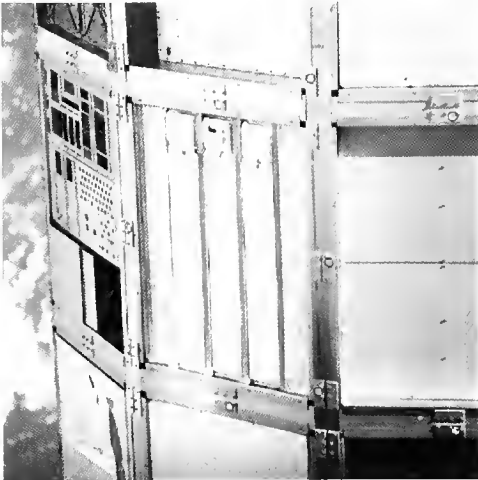
Figure 202 (In Flight). The experiment consisted of three transverse flat-plate heat pipe modules, a power system for the heaters, a data acquisition and storage system, and an aluminum support structure. The surface of the experiment that was exposed to the space environment consisted of the exterior surfaces of the three heat pipe modules and silvered Teflon film. Thermal blankets covered the aluminum mounting hardware and openings between the hardware and the tray sidewalls. The raised surface at the end of each heat pipe module contained the fluid reservoir. The specular surface of the silvered Teflon film has become diffuse and appears white with numerous impact craters; black specks are visible on the white surfaces. Some areas of pronounced discoloration are visible.

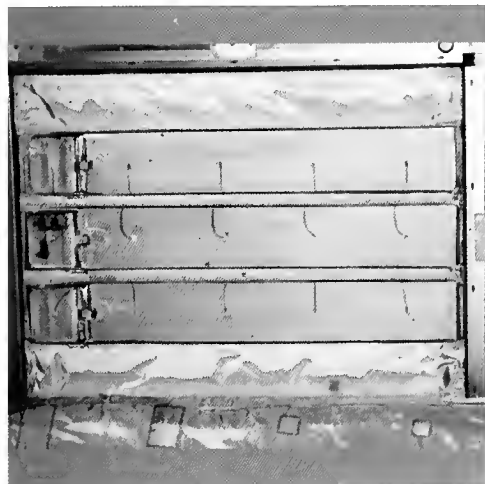
Figure 203 (Postflight). The thermal blanket with the patches across the lower edge of the photograph was part of the RMS thermal cover and was not associated with the experiment S1002. The specular surface of the silvered Teflon film has become diffuse and appears white. Numerous impact craters, black specks, and other discolorations are visible.

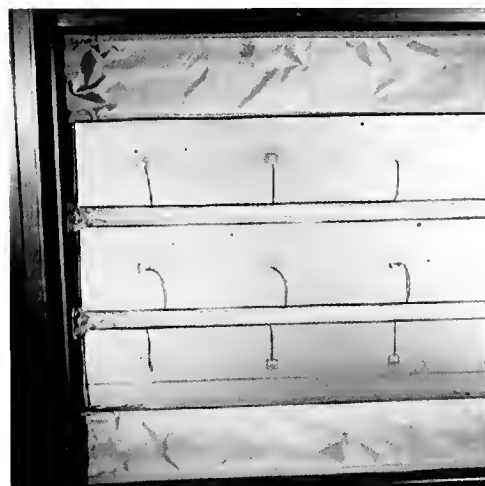
Figure 204 (Postflight). This photograph of the left of the tray shows that the silvered Teflon film now appears diffuse. Space debris impacts appear as small black dots.

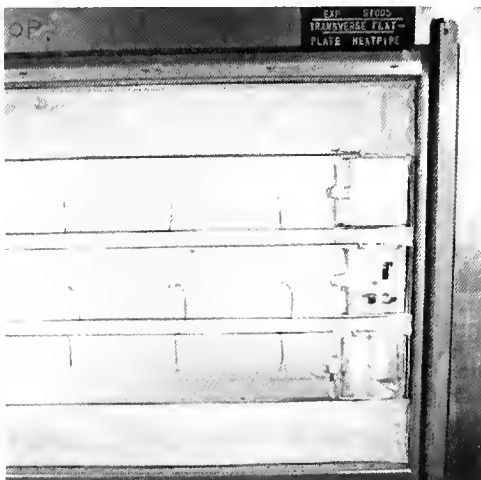
Figure 205 (Postflight). This photograph of the right of the tray shows that the silvered Teflon film now appears diffuse. Space debris impacts appear as small black dots. There is an area of brown discoloration on the right end of the center heat pipe module.

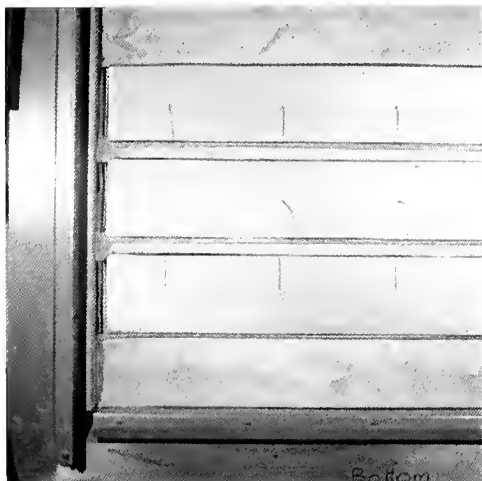
Figure 206 (Postflight). This photograph of the lower left of the tray shows that the silvered Teflon film now appears diffuse. Space debris impacts appear as small black dots.

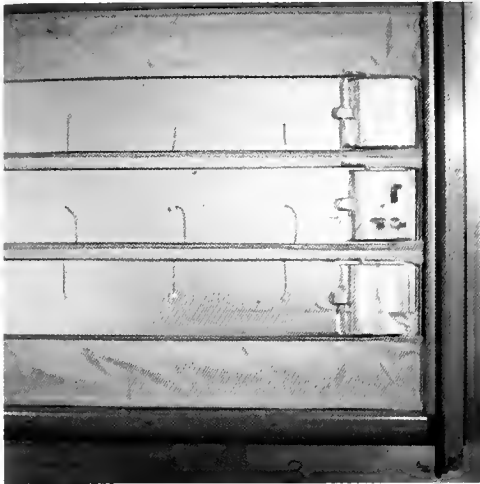
Figure 207 (Postflight). This photograph of the lower right of the tray shows that the silvered Teflon film now appears diffuse. Space debris impacts appear as small black dots. There is an area of brown discoloration on the right end of the center heat pipe module.

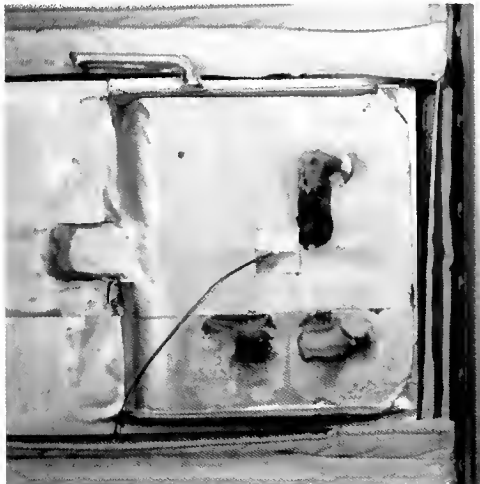
Figure 208 (Postflight). This close-up photograph is of the discolored area on the right end of the center heat pipe module.

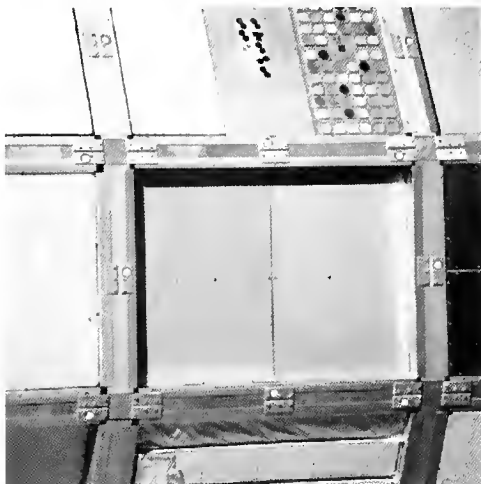
Figure 209 (In Flight). The discolorations on the lower left sidewall of the experiment tray appear to be fingerprints from prelaunch handling. A portion of the pink and greenish-gray tint on the two debris panels are by-products of the chromic anodize coating process; however, part of the intensity can be attributed to reflections of the blue sky. The vertical streaks on the right debris panel are by-products of chromic anodizing that have been enhanced by the blue reflection. A light irregular discoloration is visible on the left debris panel; it starts near the center of the left edge and progresses down and to the right. The light band along the vertical edge of the left debris panel is a reflection from the tray sidewall.

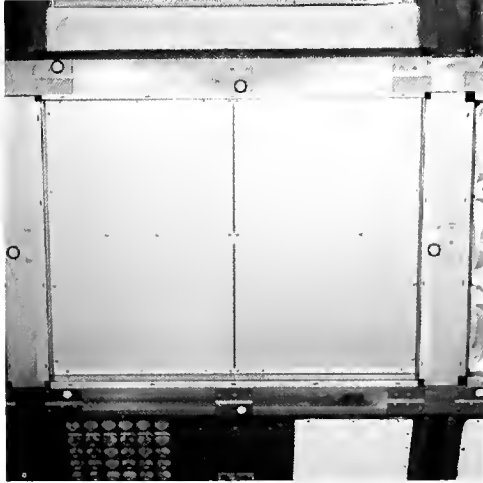
Figure 210 (Postflight). The postflight photograph was taken in the SAEF II at KSC prior to the removal of the experiment from the LDEF. The pink and greenish-gray tints on the two debris panels are by-products of the chromic anodize coating process and are not attributed to contamination or exposure to the space environment. The dark streaks observed on the right debris panel in the in-flight photograph are no longer visible because the reflection of the sky is not present. However, the light irregular discoloration starting near the center of the left edge is clearly visible on the left debris panel. The light band along the sides and across the bottom of the panels is caused by light reflecting from the tray sidewall.

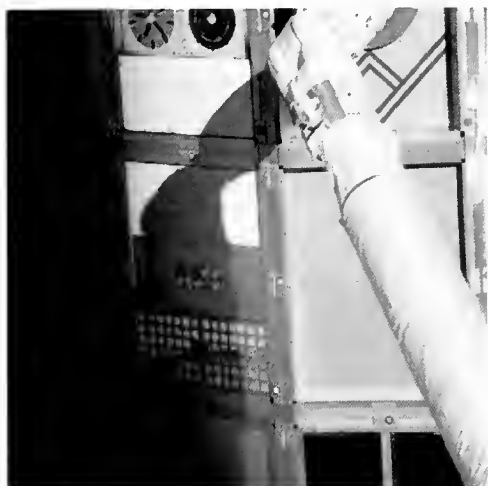
Figure 212
Photo No.: S32-78-026
Dup. Neg. No.: L90-10429
LISAR No.: EL-1994-00005
Photo Credit: JSC
Photo Date: 1/12/90
Location: In Flight
Subject: In-Flight Survey of Tray B12

Figure 212 (In Flight). The in-flight photograph is covered by the shadow from the orbiter RMS arm and cannot be readily compared with the preflight photograph. The surface area that can be observed does not seem to be significantly degraded.

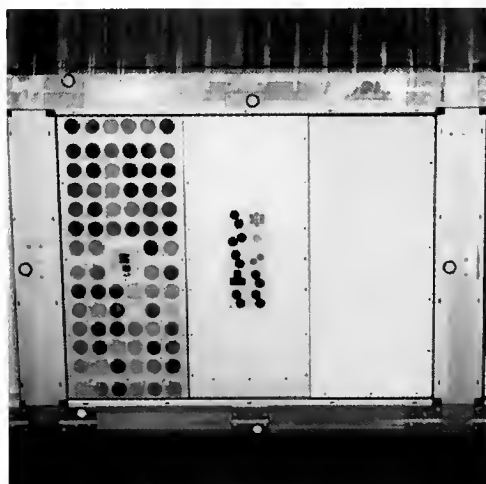
Figure 213
Photo No.: KSC-390C-1069.12
Dup. Neg. No.: L90-13492
LISAR No.: EL-1994-00204
Photo Credit: KSC
Photo Date: 2/8/90
Location: KSC SAEF II
Subject: Postflight Survey of Tray B12

Figure 213 (Postflight). The postflight photograph shows little change to the exposed surfaces when compared with the preflight photograph. Although not noticeable in the photograph, a light coating of contamination was visible on all experiment surfaces in this location. The difference in the colors of the IDE detectors that are located on the left mounting plate is a result of the reflected surroundings and is not related to space exposure. The EPDS thermal cover on the right side of the tray shows a light coating of brown contamination on the Chemglaze II A-276 white paint. Markings along the top of the photograph are due to film processing.

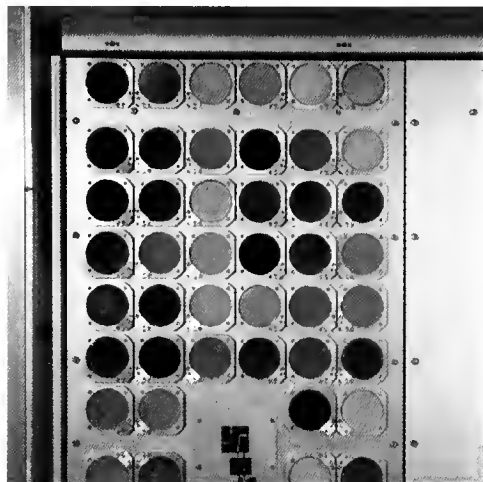
Figure 214 (Postflight). This photograph is of the upper left one-sixth of the tray. The difference in the colors of the IDE detectors is a result of the reflected surroundings and is not related to space exposure. The solar sensor located near the bottom of the photograph has changed little. The color of the solar array baseplate shows indications of contamination and appears to be darker than the detector mounting plate. A close observation of the detector surfaces reveals that some damage has occurred from meteoroid or debris impacts. One impact crater is visible on the detector located in the sixth row down from the top and the fifth row from the left. Other impacts, smaller in size, show as small white dots on the surface of the detectors.

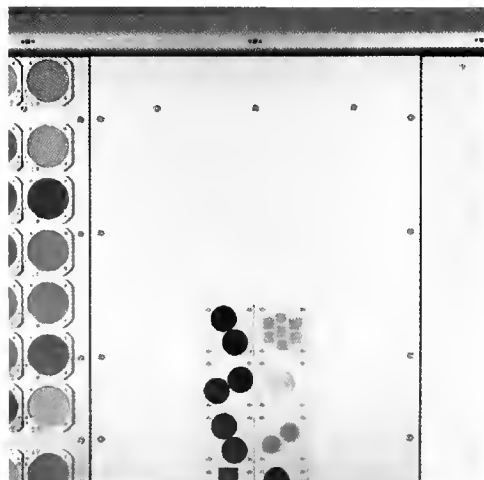
Figure 215 (Postflight). This photograph is of the upper center one-sixth of the tray. The center section cover plate shows little change except that a light coat of brown contamination can be observed on all surfaces. The color of the bonding material, which was used to secure several thin sapphire specimens to individual mounting plates at the bottom of the photograph, has changed from pink to gold. For one specimen, the bonding material is more gray than gold in color. This color difference has been attributed to the specimen being considerably thicker.

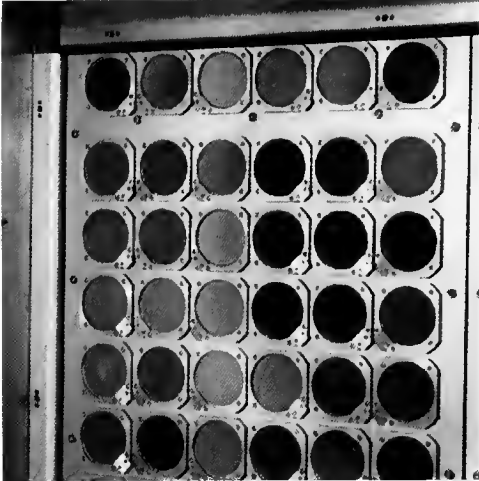
Figure 216
Photo No.: KSC-390C-1739.06
Dup. Neg. No.: L91-8197
LISAR No.: EL-1994-00236
Photo Credit: KSC
Photo Date: 3/8/90
Location: KSC SAEF II
Subject: Close-up of Upper Left of Tray B12

Figure 216 (Postflight). This close-up photograph is of the upper left one-sixth of the tray. The different colors of the impact detectors are caused by reflections of the surroundings. There are some space debris impact craters visible on some sensors. A large impact crater is visible on the sensor located second from the right in the bottom row. There also appear to be areas of discoloration or contamination around the edges of some sensors.

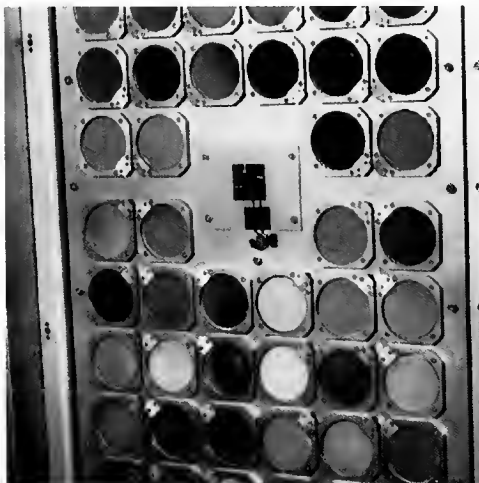
Figure 217
Photo No.: KSC-390C-1739.07
Dup. Neg. No.: L91-8198
LISAR No.: EL-1994-00237
Photo Credit: KSC
Photo Date: 3/8/90
Location: KSC SAEF II
Subject: Postflight Detail of Center Left of Tray B12

Figure 217 (Postflight). This photograph is of the center left one-third of the tray. Space debris impact craters are visible on some of the sensors. The different colors of the impact detectors are caused by reflections of the surroundings. Some reflections of room surroundings are visible in sensors in the left row. There also are areas of discoloration or contamination on or around the edges of some sensors. The solar sensor located near the bottom of the photograph has changed little. The color of the solar array baseplate shows indications of contamination and is a little darker than the detector mounting plate.

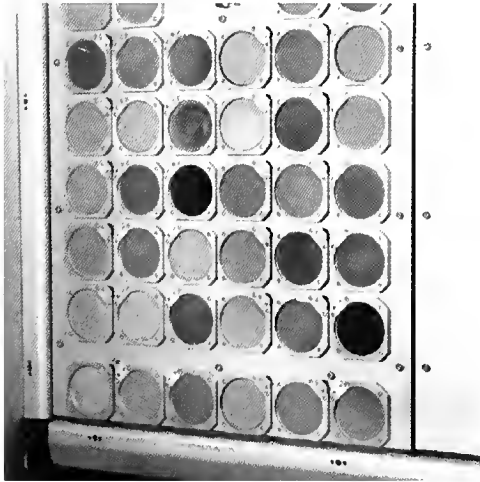
Figure 218 (Postflight). This photograph is of the lower left one-sixth of the tray. Space debris impact craters are visible on some of the sensors. There also appear to be areas of discoloration or contamination on or around the edges of some sensors. The different colors of the impact detectors are caused by reflections of the surroundings.

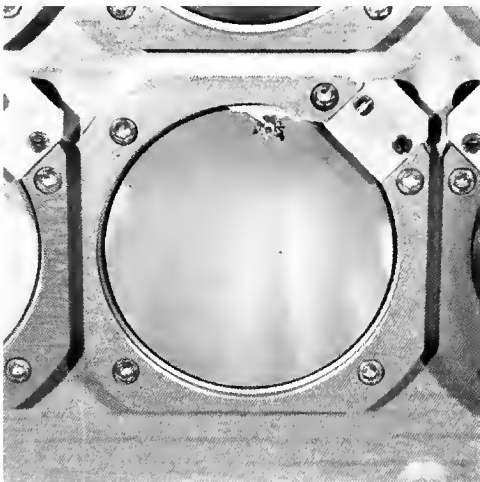
Figure 219 (Postflight). This close-up photograph is of a sensor and shows a space debris impact crater. This sensor is the second from the right in the second row from the bottom in the photograph shown in figure 218. Other small impacts are also visible.

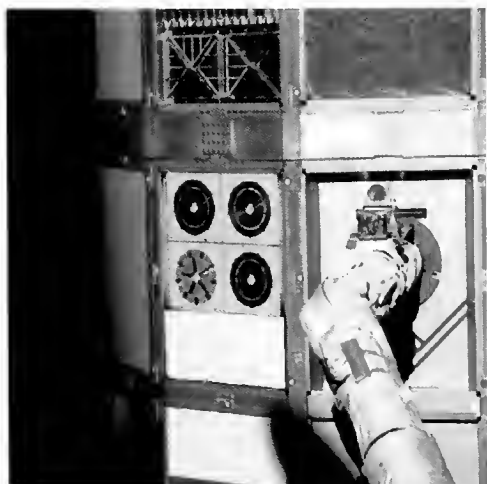
Figure 221
Photo No.: S32-89-048
Dup. Neg. No.: L90-10501
LISAR No.: EL-1994-00135
Photo Credit: JSC
Photo Date: 1/12/90
Location: In Flight
Subject: In-Flight Survey of Tray C1

Figure 221 (In Flight). The grapple tray assembly appears to be without physical damage. The camera on the RMS end effector blocks out over half the target attached to the top edge of the grapple fixture. The RMS wrist joint and shadow partially block a view of the black chevrons. The chromic-anodized aluminum mounting plate and the upper and lower flanges of the tray are discolored by a light tan stain.

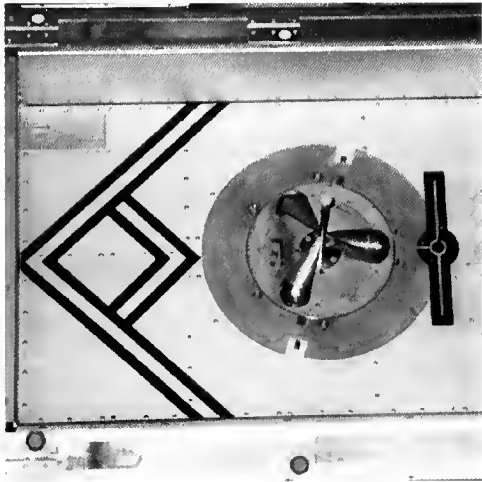
Figure 222 (Postflight). The grapple tray assembly appears to be without physical damage. The dark irregular discoloration on the lower right corner of the grapple fixture mounting plate is an abrasion that existed preflight. The pinkish tint on the mounting plate is a by-product of the chromic anodizing process and is not attributed to exposure to the space environment. The stripes on the black camera target and the tip of the vertical rod on the target have changed from white to brown. The light band along the right edge of the grapple fixture mounting plate is caused by light reflecting from the tray sidewalls.

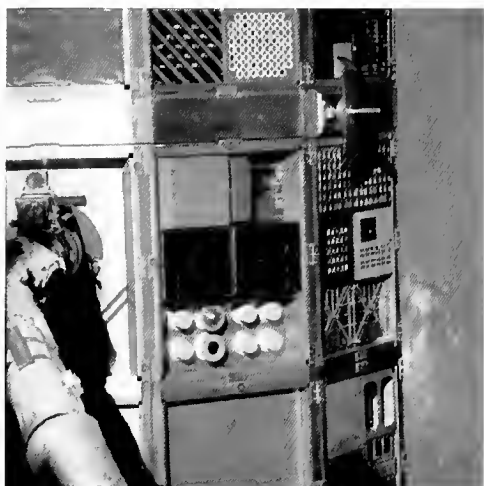
Figure 224
Photo No.: S32-89-029
Dup. Neg. No.: L90-10498
LISAR No.: EL-1994-00133
Photo Credit: JSC
Photo Date: 1/12/90
Location: In Flight
Subject: In-Flight Survey of Tray C2

Figure 224 (In Flight). A brown stain is on the experiment hardware within the tray. Experiment AO015 has survived the extended mission with no visible damage. The Kapton covers are intact and all hardware is securely in place. Experiment AO187-2 capture cells have been severely degraded. Few, if any, of the 40 capture cell metallized Mylar covers survived the total mission. For many cells, pieces of the failed capture cover have curled into tight conical needles and are attached to the edges of the aluminum mounting frame.

The EECC containing experiment M0006 appears to be in excellent shape.

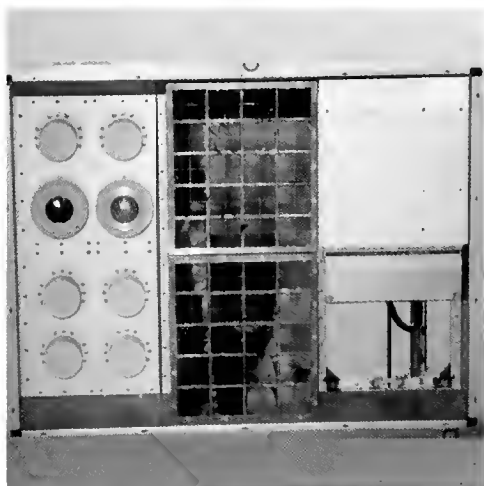
Figure 225
Photo No.: KSC-390C-609.09
Dup. Neg. No.: L92-17835
LISAR No.: EL-1994-00121
Photo Credit: KSC
Photo Date: 1/30/90
Location: KSC OPF
Subject: Postflight Survey of Tray C2

Figure 225 (Postflight). Most hardware is coated with a light brown or tan stain. Only one metallized Mylar cover for experiment AO187-2 survived the total mission. For other cells, pieces of the failed metallized Mylar cover curled into a tight conical shape and adhered to the edges of the aluminum mounting frame.

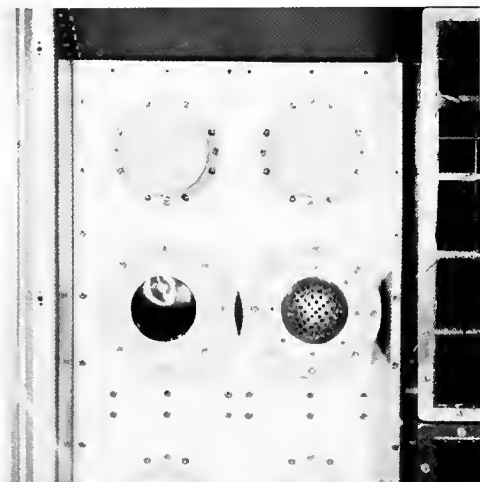
Figure 226 (Postflight). This photograph is of the upper left one-sixth of the tray. The bio-stack canisters have no damage, but there is a dimple in one orange Kapton cover dome. The canisters were white prior to flight, but are now a light tan.

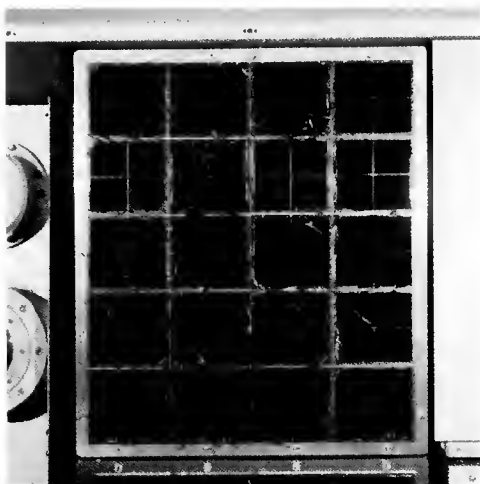
Figure 227 (Postflight). This photograph is of the upper center one-sixth of the tray. All the visible metallized Mylar capture cell covers have rolled up and are hanging loose. There are reflections of surrounding areas in the face of some capture cells.

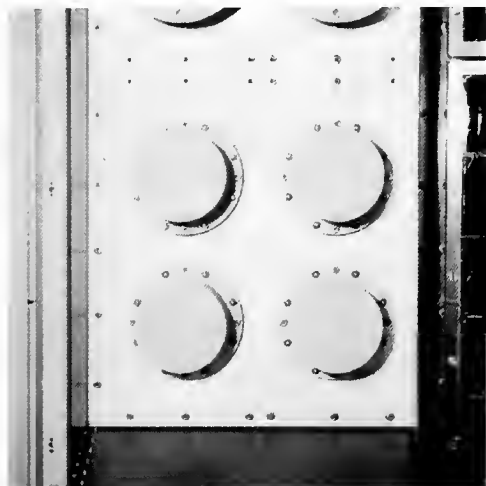
Figure 228
Photo No.: KSC-390C-1918.05
Dup. Neg. No.: L91-9051
LISAR No.: EL-1994-00429
Photo Credit: KSC
Photo Date: 3/13/90
Location: KSC SAEF II
Subject: Postflight Detail of Lower Left of Tray C2

Figure 228 (Postflight). This photograph is of the lower left one-sixth of the tray. The canisters appear undamaged. The biostack canisters that were white prior to flight now have a light tan discoloration.

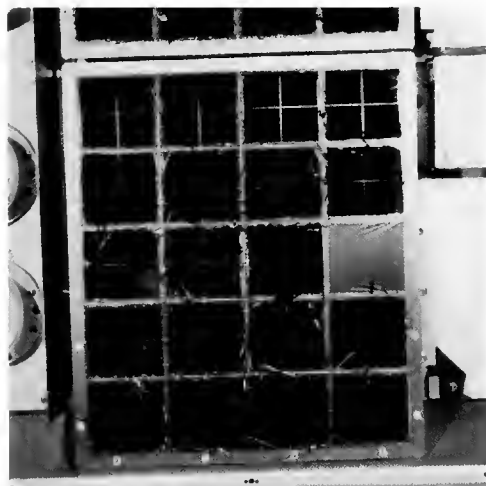
Figure 229
Photo No.: KSC-390C-1918.06
Dup. Neg. No.: L91-9052
LISAR No.: EL-1994-00430
Photo Credit: KSC
Photo Date: 3/13/90
Location: KSC SAEF II
Subject: Postflight Detail of Lower Center of
Tray C2

Figure 229 (Postflight). This photograph is of the lower center one-sixth of the tray. All but one of the metallized Mylar covers have rolled up and are hanging loose. There are reflections of surrounding areas in the face of some capture cells.

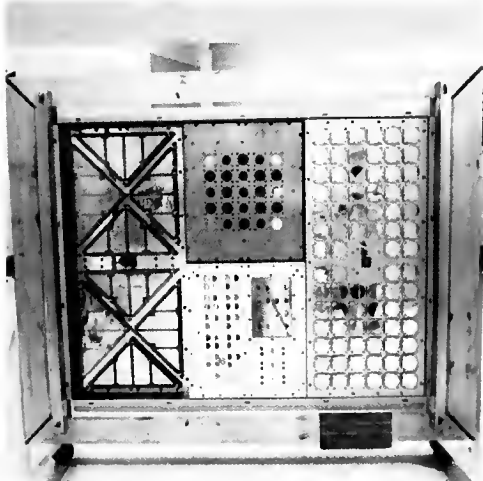
Figure 230
Photo No.: KSC-384C-15.01
Dup. Neg.: L84-7015
LISAR No.: EL-1994-00332
Photo Credit: KSC
Photo Date: 1/9/84
Location: KSC SAEF II
Subject: Preflight Survey of Tray C3

Figure 230 (Preflight). Experiment AO023 in the left one-third of the tray utilized thin-film detectors bonded to brass mesh supports. The support mesh was then bonded to die-cast aluminum frames. The die-cast aluminum frames, stacked two high, were placed over a polished aluminum stop plate and the combined assembly was bolted to an aluminum mounting plate.

Experiment AO114 in the lower center one-sixth of the tray contained 64 1-in-diameter solid samples, which included thin-film metals and nonmetals.

Experiment AO201, which was located in the right one-third of the tray, exposed 80 detectors that are described in figure 211.

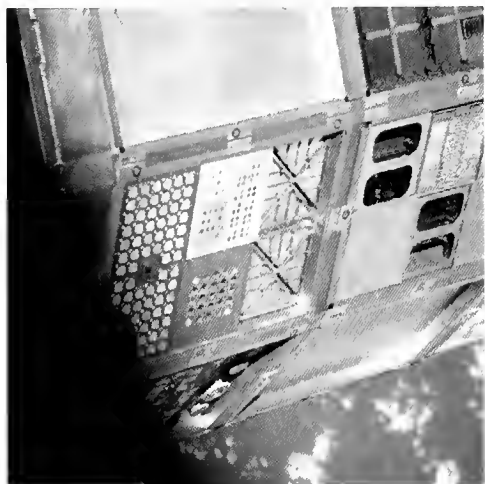
Figure 231
Photo No.: S32-77-065
Dup. Neg. No.: L90-10416
LISAR No.: EL-1994-00682
Photo Credit: JSC
Photo Date: 1/12/90
Location: In Flight
Subject: In-Flight Survey of Tray C3

Figure 231 (In Flight). There is a brown stain on the tray structure and most aluminum surfaces of experiments within the tray. Experiment AO023 appears intact. The blue tint on the detector foils and also on the polished aluminum stop plates between the detector stacks is the reflection of the sky on the metallic surfaces.

The S13G-LO white paint on experiment AO114 has turned to a light tan with darker areas near the coverplate edges and above the polished aluminum cover plate. The blue tint on the polished aluminum cover plate and some of the specimen materials is attributed to a reflection of the sky.

The hardware of experiment AO201 that is not in shadow appears to have a thin brown film or stain on the exposed surfaces. The colors in the mirrorlike surface of the detectors are a reflection of the sky and the clouds.

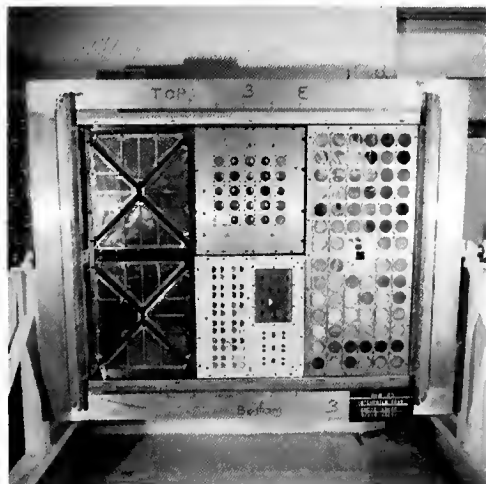
Figure 232
Photo No.: KSC-390C-1558.02
Dup. Neg. No.: L91-9090
LISAR No.: EL-1994-00213
Photo Credit: KSC
Photo Date: 3/5/90
Location: KSC SAEF II
Subject: Postflight Survey of Tray C3

Figure 232 (Postflight). Experiment surfaces have a brown stain that is consistent with other areas on the trailing side of the LDEF. Most noticeable is that the coverplate of experiment AO114, which was painted with white paint (S13G-LO), is now light tan.

Experiment AO023 has no visible damage. The die-cast frame, the mesh, the detector foils, and the bond joints are intact. Reflections from the photographic light sources are visible on the surfaces of specimens located in the cavities behind the cover plate.

The colors and designs on detectors of experiment AO201 are reflections of the surrounding area.

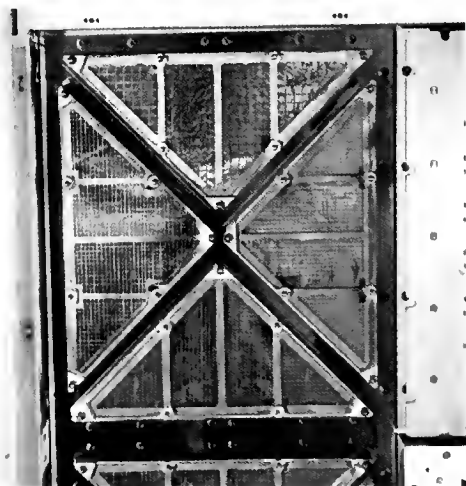
Figure 233
Photo No.: KSC-390C-1558.03
Dup. Neg. No.: L91-9091
LISAR No.: EL-1994-00339
Photo Credit: KSC
Photo Date: 3/5/90
Location: KSC SAEF II
Subject: Postflight Detail of Upper Left of Tray C3

Figure 233 (Postflight). This photograph is of the upper left one-sixth of the tray. The hardware of experiment AO023 appears intact, but some discoloration on the mounting hardware surfaces is apparent. Considerable staining is visible along the bond line between the support mesh and die-cast frame where the adhesive may not have been completely cleaned during pre-launch preparations. Reflections in the foil surfaces are visible.

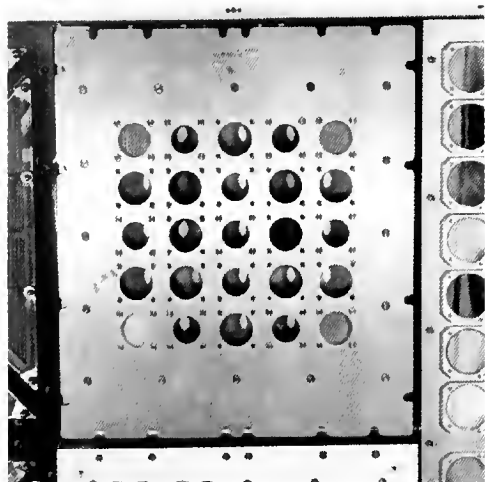
Figure 234
Photo No.: KSC-390C-1558.04
Dup. Neg. No.: L91-9092
LISAR No.: EL-1994-00340
Photo Credit: KSC
Photo Date: 3/5/90
Location: KSC SAEF II
Subject: Postflight Detail of Upper Center of Tray C3

Figure 234 (Postflight). This photograph is of the upper center one-sixth of the tray. Experiment AO034 has some uniform brown discoloration on the cover plate surface. Reflections from photographic lights are visible on the sensor surfaces.

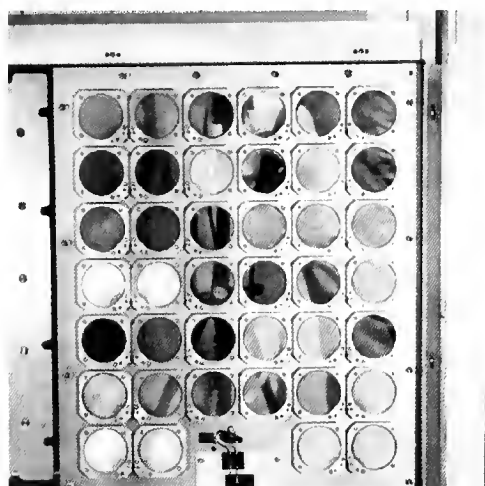
Figure 235
Photo No.: KSC-390C-1558.05
Dup. Neg. No.: L91-9093
LISAR No.: EL-1994-00351
Photo Credit: KSC
Photo Date: 3/5/90
Location: KSC SAEF II
Subject: Postflight Detail of Upper Right of Tray C3

Figure 235 (Postflight). This photograph is of the upper right one-sixth of the tray. The sensors of experiment AO201 are intact. There is a brown discoloration on the detector frames and baseplate. A reflection of the room surroundings is visible in the sensor surfaces.

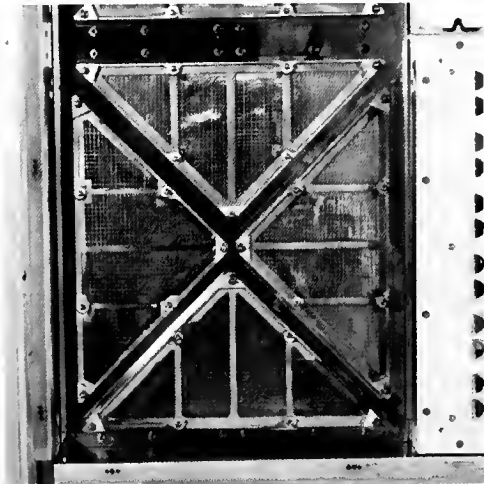
Figure 236
Photo No.: KSC-390C-1558.06
Dup. Neg. No.: L91-9094
LISAR No.: EL-1994-00352
Photo Credit: KSC
Photo Date: 3/5/90
Location: KSC SAEF II
Subject: Postflight Detail of Lower Left of Tray C3

Figure 236 (Postflight). This photograph is of the lower left one-sixth of the tray. The hardware of experiment AO023 is intact, but some discoloration on the mounting hardware surfaces is apparent. Considerable staining is visible along the bond line between the support mesh and the die-cast frame where the adhesive may not have been completely cleaned during prelaunch preparations. Reflections in the foil surfaces are visible.

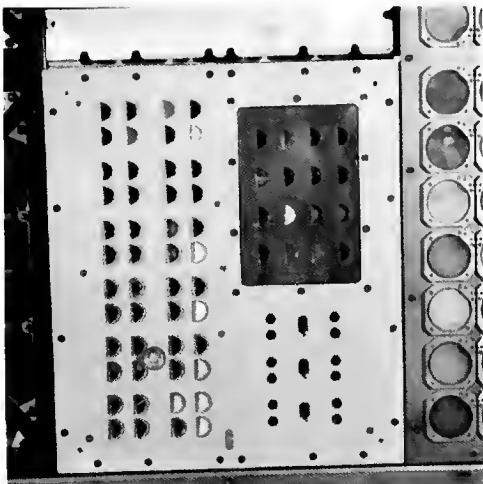
Figure 237
Photo No.: KSC-390C-1558.07
Dup. Neg. No.: L91-9095
LISAR No.: EL-1994-00364
Photo Credit: KSC
Photo Date: 3/5/90
Location: KSC SAEF II
Subject: Postflight Detail of Lower Center of
Tray C3

Figure 237 (Postflight). This photograph is of the lower center one-sixth of the tray. The sensors of experiment AO114 seem to be intact. The paint that was originally white on the faceplate is now a uniform light tan. The polished aluminum face plate insert in the upper right quadrant has become darker.

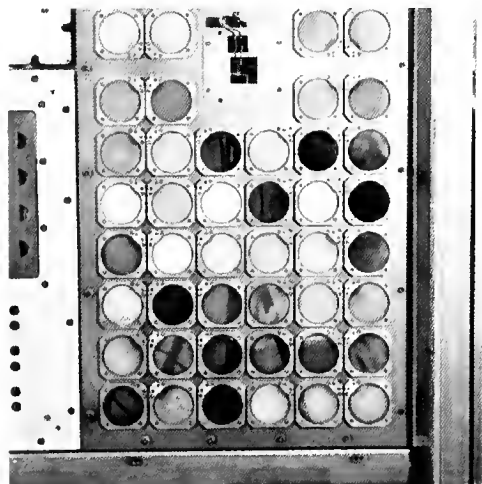
Figure 238 (Postflight). This photograph is of the lower right one-sixth of the tray. The sensors of experiment AO201 are intact. There is a brown discoloration on the detector frames and baseplate. A reflection of the nearby surroundings is visible in the sensor surfaces.

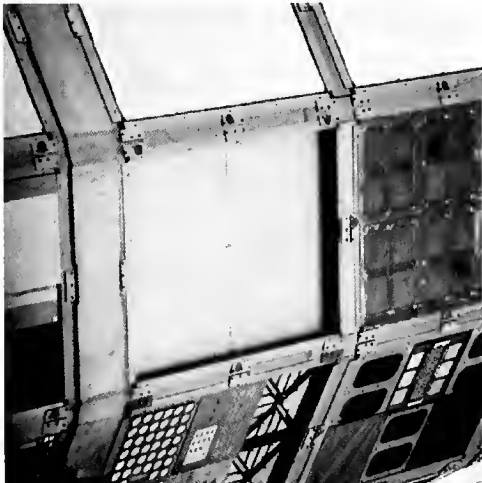
Figure 239 (In Flight). The greenish-gray tint on the debris panels is a by-product of the chromic anodize coating process. The dark green smudge along the top right edge of the left debris panel is the result of improper cleaning after prelaunch handling. The dark band across the bottom of the panels is caused by a shadow from the tray sidewall.

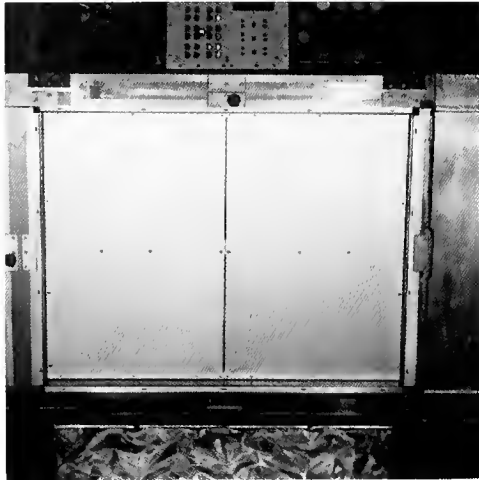
Figure 240
Photo No.: KSC-390C-832.05
Dup. Neg. No.: L90-13352
LISAR No.: EL-1994-00173
Photo Credit: KSC
Photo Date: 2/7/90
Location: KSC SAEF II
Subject: Postflight Survey of Tray C4

Figure 240 (Postflight). The greenish-gray and pink tints on the two debris panels are by-products of the chromic anodize coating process and are not attributed to contamination or exposure to the space environment. The smudges on the panels along the bottom center of the tray are the result of improper cleaning after panel installation. The light band along the sides and across the top of the panels is caused by light reflecting from the tray sidewalls.

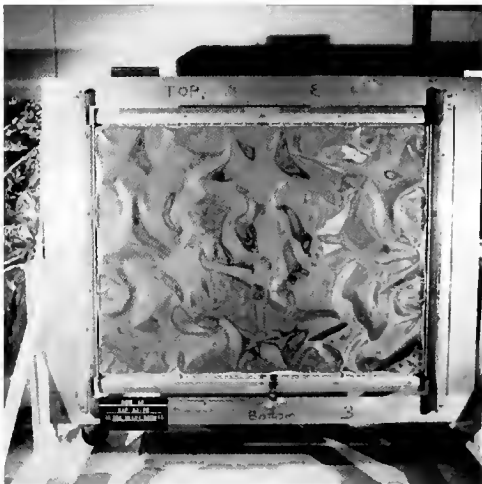
Figure 241 (Postflight). The thermal cover appears to be specular with no apparent damage. The cover is less taut than in the in-flight photograph and the locations of Velcro attachment pads are less prominent. The green on the right one-third of the thermal cover are reflections from the surroundings. The scallop effect around the cover edges occurs between the attachment pads and shows the upper edge of the support frame. The ground strap is in place with no visible damage; however, it is a deeper copper color than in the prelaunch photograph.

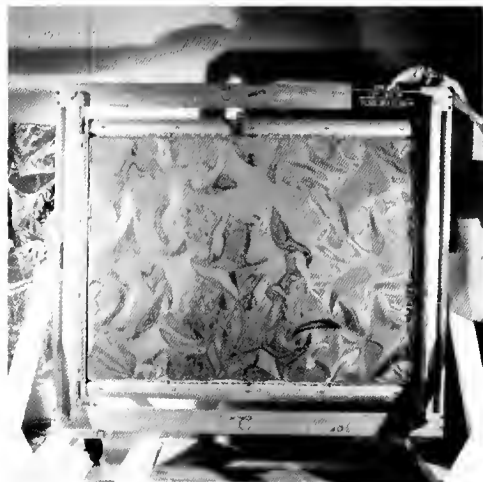
Figure 242 (Postflight). The thermal cover appears to be specular with no apparent damage. The green on the right one-third of the thermal cover are reflections from the surroundings. The ground strap is in place with no visible damage; however, it is a deeper copper color than in the prelaunch photograph.

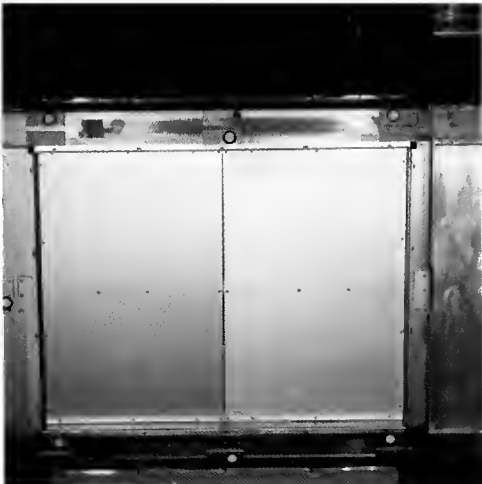
Figure 243 (Postflight). The pink and greenish-gray tints on the two debris panels are by-products of the chromic anodize coating process and are not attributed to contamination or exposure to the space environment. The two white spots in the lower left quadrant of the left debris panel appear to be debris impact craters. The light band along the right side and across the bottom of the panels is caused by light reflecting from the tray sidewalls.

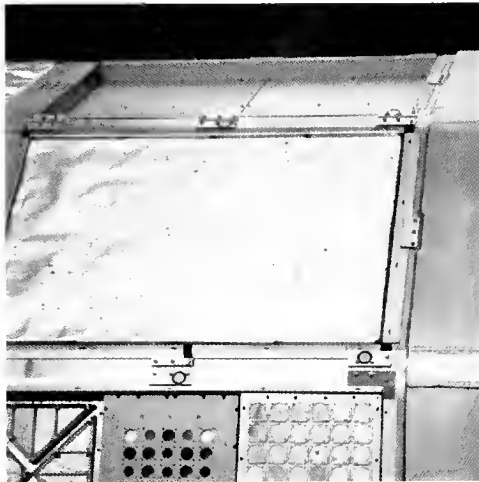
Figure 244 (In Flight). The ground strap located in the center of the lower flange is intact but with a much darker copper color than in the prelaunch photograph. The thermal cover surface appears to have changed from specular to opaque (glossy white) and to be marked with many black dots of various sizes that appear to be impacts or penetrations. Many discolorations have a black center encircled by a brown halo. The cover appears to be more taut than in the prelaunch photograph and the locations of Velcro attachment pads appear as oblong indentations in the thermal cover.

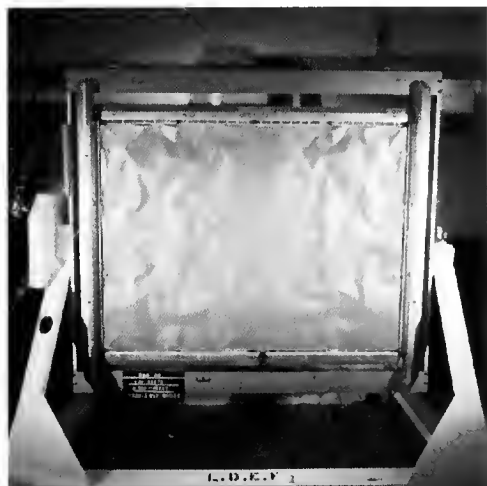
Figure 245
Photo No.: KSC-390C-1543.09
Dup. Neg. No.: L91-8886
LISAR No.: EL-1994-00212
Photo Credit: KSC
Photo Date: 3/2/90
Location: KSC SAEF II
Subject: Postflight Survey of Tray C8

Figure 245 (Postflight). The thermal cover surface appears to have changed from specular to opaque (glossy white) with many black dots of various sizes that appear to be impact or penetration discolorations. Many of the discolorations appear to have a black center encircled by a brown halo and then by a white halo. Other white circular discolorations also appear on the cover surface. The darker discolorations are probably the result of craters penetrating the 5-mil Teflon film, thus allowing atomic oxygen to oxidize or erode the layer of vapor-deposited silver beneath. An item of interest is the impact crater in the lower right corner of the cover that has a spray pattern originating from the point of impact. The cover is not as taut as in the in-flight photograph and the locations of Velcro attachment pads are not as prominent. The ground strap is in place with no visible damage; however, it is a deeper copper color.

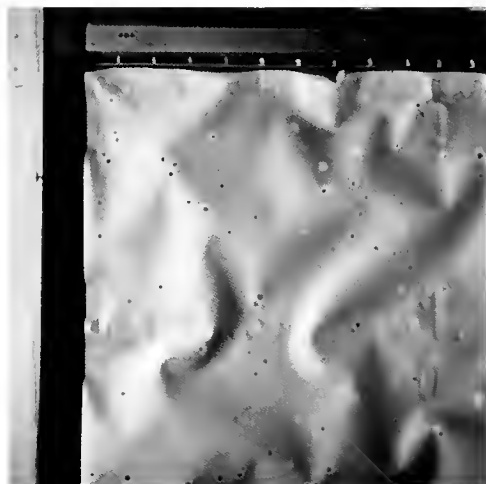
Figure 246
Photo No.: KSC-390C-1543.10
Dup. Neg.: L91-8887
LISAR No.: EL-1994-00154
Photo Credit: KSC
Photo Date: 3/2/90
Location: KSC SAEF II
Subject: Postflight Detail of Upper Left of Tray C8

Figure 246 (Postflight). This photograph is of the upper left one-sixth of the tray. The thermal cover appears opaque with numerous discolored impacts or penetrations. The thermal cover Velcro attachment pads are evident.

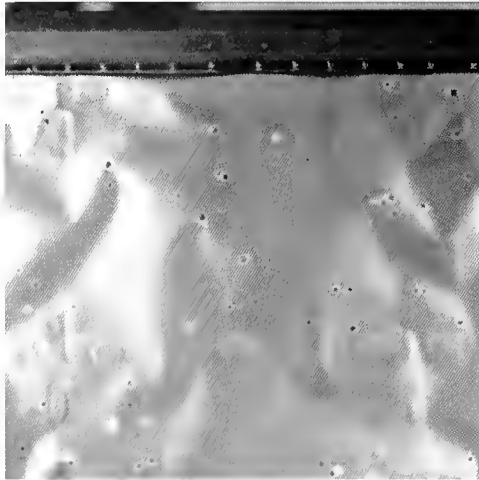
Figure 247 (Postflight). This photograph is of the upper center one-sixth of the tray. The thermal cover appears opaque with numerous discolored impacts or penetrations. The thermal cover Velcro attachment pads are evident.

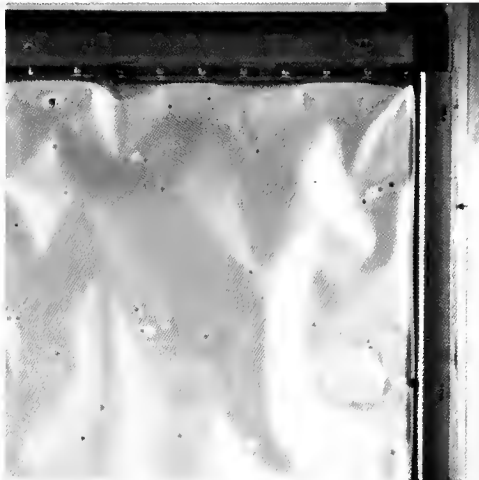
Figure 248 (Postflight). This photograph is of the upper right one-sixth of the tray. The thermal cover appears opaque with numerous discolored impacts or penetrations. The thermal cover Velcro attachment pads are evident.

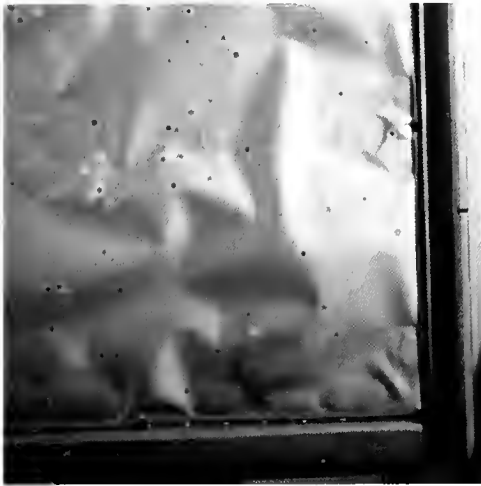
Figure 249 (Postflight). This photograph is of the lower right one-sixth of the tray. The thermal cover appears opaque with numerous discolored impacts or penetrations. The thermal cover Velcro attachment pads are evident.

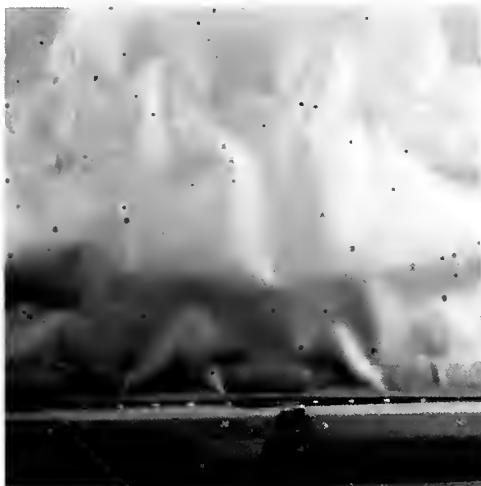
Figure 250 (Postflight). This photograph is of the lower center one-sixth of the tray. The thermal cover appears opaque with numerous discolored impacts or penetrations. The thermal cover Velcro attachment pads are evident.

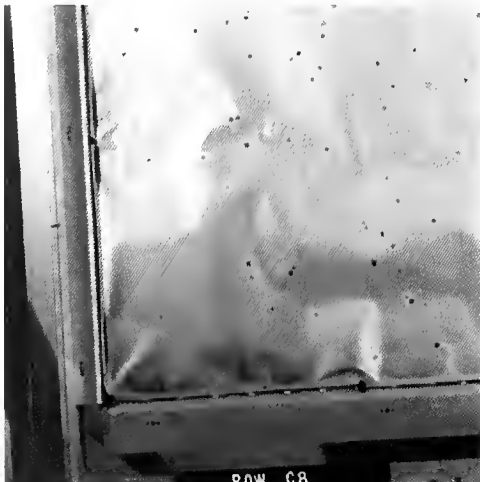
Figure 251 (Postflight). This photograph is of the lower left one-sixth of the tray. The thermal cover appears opaque with numerous discolored impacts or penetrations. The thermal cover Velcro attachment pads are evident.

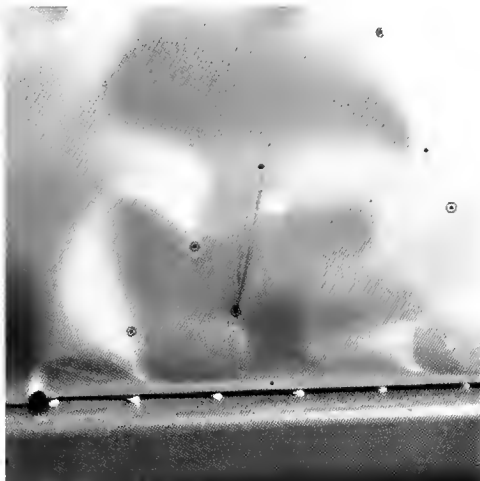
Figure 252 (Postflight). This close-up is of an impact or penetration in the lower right of the tray. A pronounced spray pattern extends away from the point of impact.

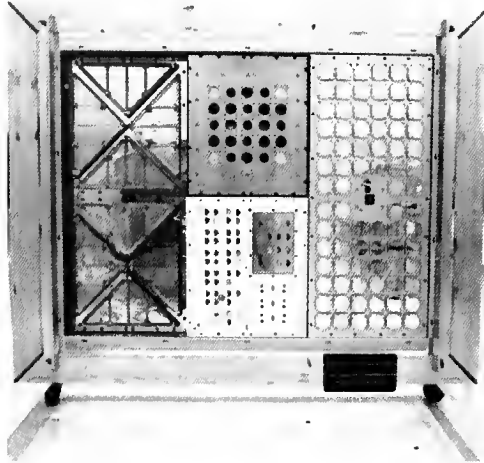
Figure 253 (Preflight). The prelaunch photograph shows the location of four experiments integrated into a 3-in-deep tray. Experiment AO023 is located in the left one-third, experiment AO034 in the upper center, experiment AO114 in the lower center, and experiment AO201 in the right one-third of the tray. Experiment AO201 is described in figure 211 and the other experiments are described in figure 230.

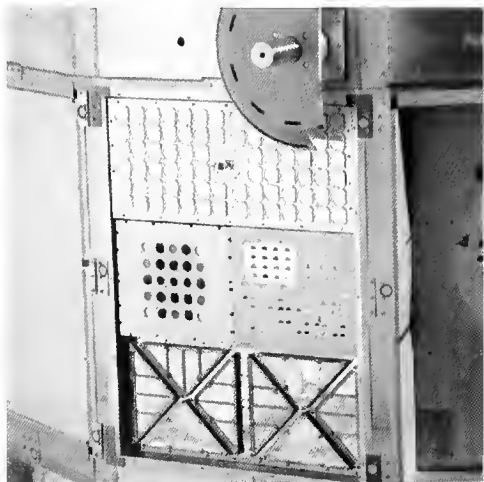
Figure 254 (In Flight). The tray appears to be unchanged from the preflight condition except for a little discoloration around some fasteners and on the mounting plates. Reflections of the surroundings appear to exist on some sensor surfaces. All experiment hardware appears intact. The color of the center coverplates was influenced by lighting conditions.

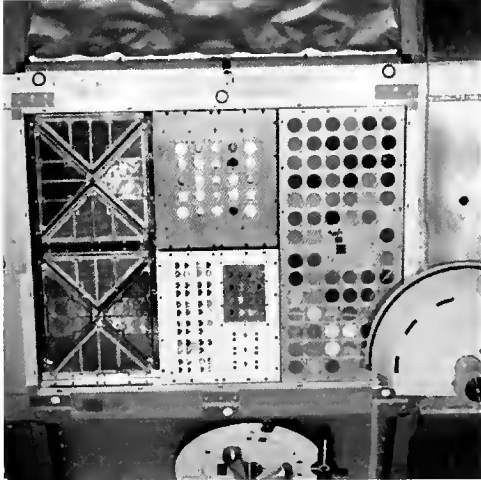
Figure 255
Photo No.: KSC-390C-1030.09
Dup. Neg. No.: L90-13407
LISAR No.: EL-1994-00143
Photo Credit: KSC
Photo Date: 2/9/90
Location: KSC SAEF II
Subject: Postflight Survey of Tray C9

Figure 255 (Postflight). The tray corner clamp blocks are unanodized aluminum, which accounts for the difference in color between the corner clamp blocks and the center clamp blocks. All experiments are intact. Reflections of the surroundings are visible in the sensor surfaces.
